Manhole Inspection Summary

Manhole # S45K__022MH

Insp Date: **4/30/08 10:24 AM**

Location Address: **s castle street**

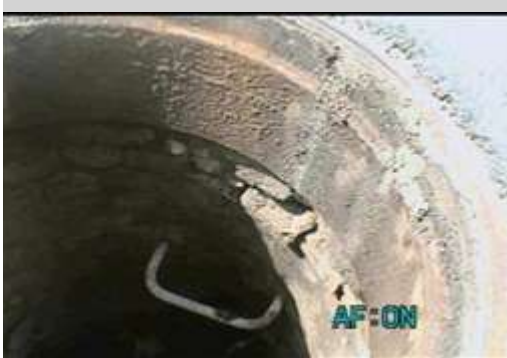
Defect 1

Condition: ☐ Sound ☐ Cracked ☐ Root Intrusion ☒ **Loose Brick** ☐ Deteriorated

chimney

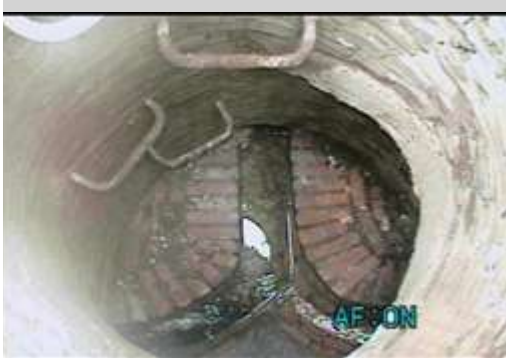
Defect 2

Count: **4** Missing: **0** ☒ **Corroded**

steps

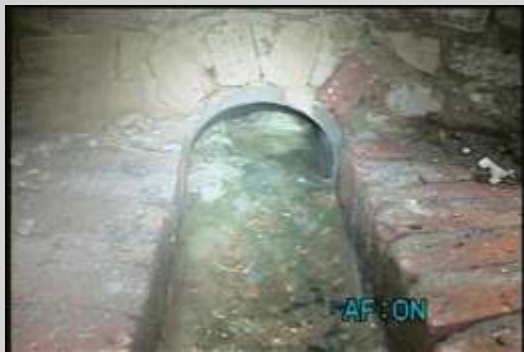
12 O'Clock Outflow

Deposits: ☐ None ☐ Mud ☒ **Sludge** ☐ Debris ☐ Grease

Silt Depth: **4** (in.) Deposits Extent: **Medium**
